# Manhole Inspection Summary

Manhole # S39GG\_025MH

Insp Date: **3/28/07 12:33 PM**

**Location** Address: **832 PRESTON ST**

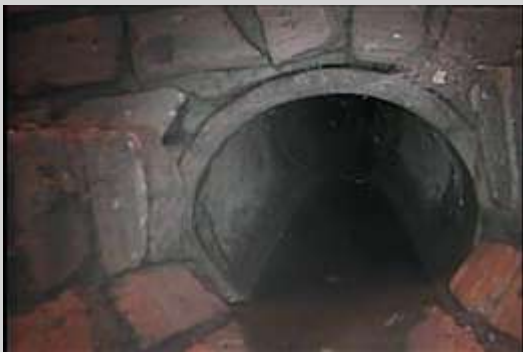
### 8 in. Circular Gravity Sewer Pipe Out @ 12 O'Clock

Rod and Bar (Angled)

Pipe Material: **Clay** ☐ Pipe Lined

Invert Depth: **10.15** (ft.) Flow Characteristics: **None**

Infiltration: **None** Pipe Seal Cond: **Unknown**

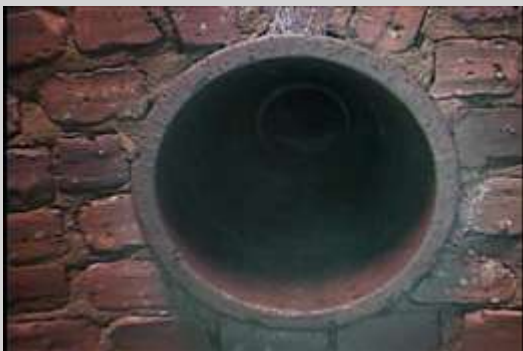
### 8 in. Circular Gravity Sewer Pipe In @ 3 O'Clock

Rod and Bar (Angled)

Pipe Material: **Clay** ☐ Pipe Lined

Infiltration: **None** Pipe Seal Cond: **Unknown**
